SUBMARINE NAVIGATION UNDER THE NORTH POLE

Robert Stewart — AIAA Member MB168215

Litton Systems, Inc.

This paper provides a brief description of the N6A Inertial Navigation System and its critical role in the Arctic exploration cruise of the USS Sargo in 1960.

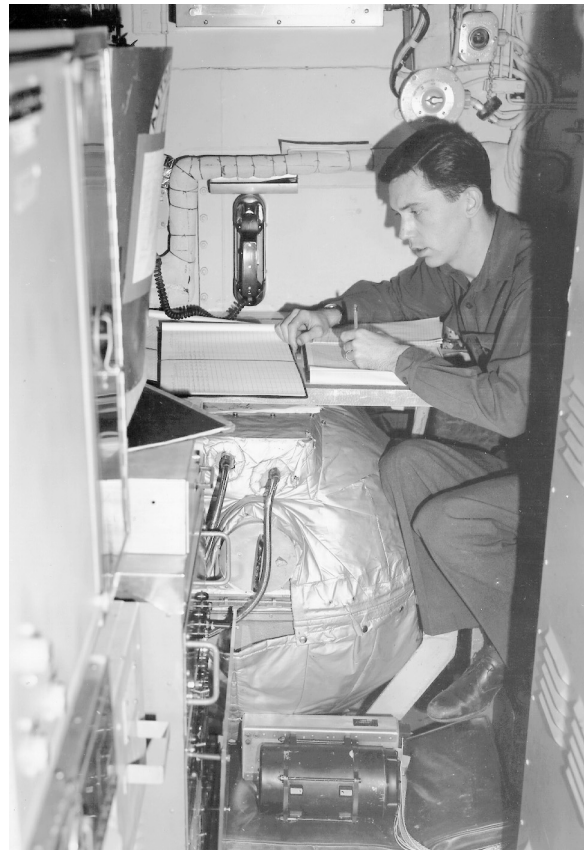
Figure 1. N6A Navigation System installed on the USS Sargo (Courtesy of US Navy)

Figure 1 is a photograph of the N6A Inertial Navigation System installation on the USS Sargo. The insulated spherical structure below the table and against the author's knee is the housing that covers the stable platform. Four gyros are mounted in the upper section of the platform with their output axes vertical. In this orientation any change in the center of gravity of the float of the gyroscope will not cause an error torque due to gravity. Two of these gyroscopes control motion about the level x-axis through the platform servo and two around the level y-axis. The two remaining gyros are mounted in the lower section of the platform along with two distance meters. These gyros control motion about the azimuth axis and therefore are mounted with their output axes horizontal. Instead of controlling a particular axis of the platform continuously with one gyroscope; control is alternately switched between the gyro pairs on each axis. The rotor spin polarity is reversed for each gyro during its off-duty period. This effect is to cause the gyro drift to be alternately reversed from positive to negative instead of continuing in the same direction. This mode of operation was named NAVAN.

The distance meters consist of an electric motor that rotates about a vertical axis. The electric motor is contained within a cylinder or "float" suspended on frictionless bearings in a flotation fluid. The floated cylinder is unbalanced about the vertical axis. Acceleration acting on the unbalanced float causes it to rotate. A pick-off signal is sent to the distance meter servo, which generates a current in the electric motor inside the float. The acceleration of the electric motor reacts against the cylindrical float creating a torque that is equal and opposite to the acceleration induced torque. The acceleration of the electric motor is therefore proportional to the acceleration sensed by the distance meter, the angular velocity of the motor is proportional to velocity and the total angle that the motor rotates is proportional to distance. Thus the name distance meter.
